GLENHAM DAM

DUTCHESS COUNTY, NEW YORK
INVENTORY NO. N.Y. 72

PHASE I INSPECTION REPORT NATIONAL DAM SAFETY PROGRAM

AUGUST 1981

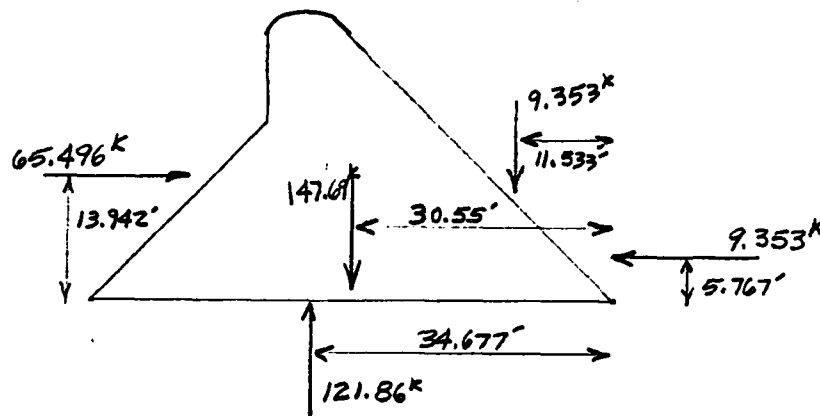
Case III Loading Diagram

$$\begin{aligned} F.S. \text{ overturning} &= \frac{(147.69)(30.55) + 9.353(11.533) + 9.353(5.767)}{(121.86)(34.677) + (65.496)(13.942)} \\ &= \frac{4673.736}{5138.884} = \underline{\underline{0.909}} \end{aligned}$$

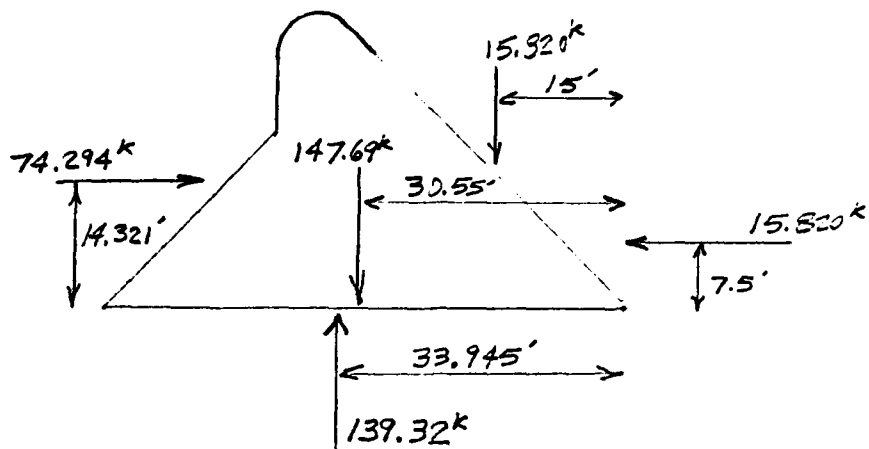
Case IV Loading Diagram

$$F.S._{\text{overturning}} = \frac{(147.69)(30.55) + (15.820)(15) + 15.820(7.5)}{(74.294)(14.321) + (139.32)(33.945)} = \frac{4367.880}{5793.182} = 0.75$$
